MM 1700-1
July, 1976

STANDARDIZED TEST PROCEDURE FOR MIDWAY'S PROCESSOR BOARDS

MIDWAY MFG. CO.

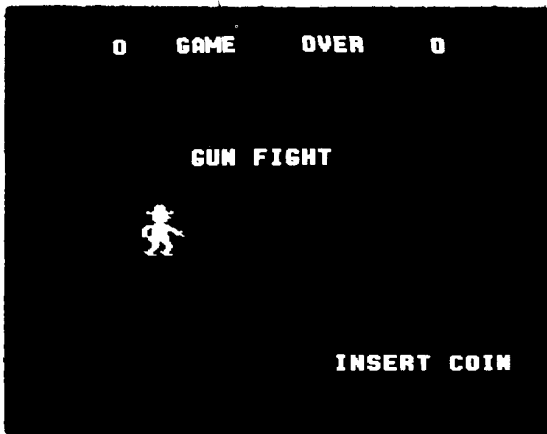
Figure 3.2-1 Good Picture with Good Program

By good picture is meant here a clear screen with the words "Game Over" and "0" on either side of it. In the case of a good Mother Board the words "Gun Fight" would be seen followed by the Cowboy coming in, shooting a bullet downwards, and walking back. During this process the words "Insert Coin" would appear on the lower right hand side temporarily (Figure 3.2-1). If all or part of this is bad it could most likely be a program problem.

(a) Gunfight

(b) Sea Wolf
